Appendix P: Skagway

Guide to direct fieldwork for cataloging anadromous water bodies in Southeast Alaska

SKAGWAY SURVEYS

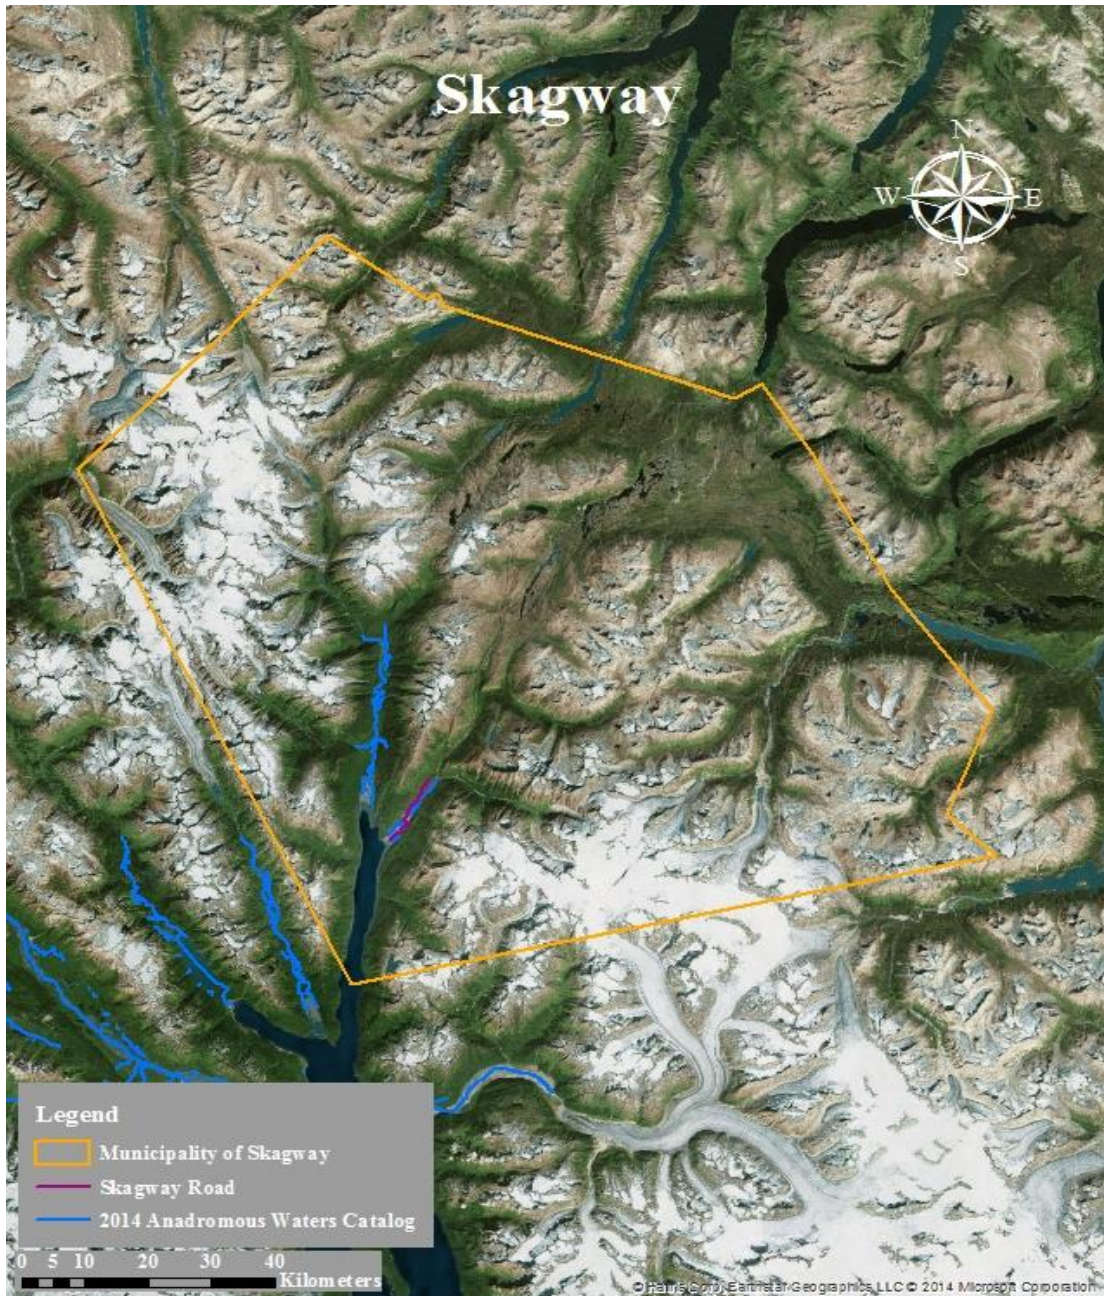
Figure 1.—Skagway survey map.

Skagway, population 1,031, is located 90 miles northeast of Juneau at the northernmost end of Lynn Canal, at the head of Taiya Inlet, and just west of the Canadian border with British Columbia (Figure 1).¹

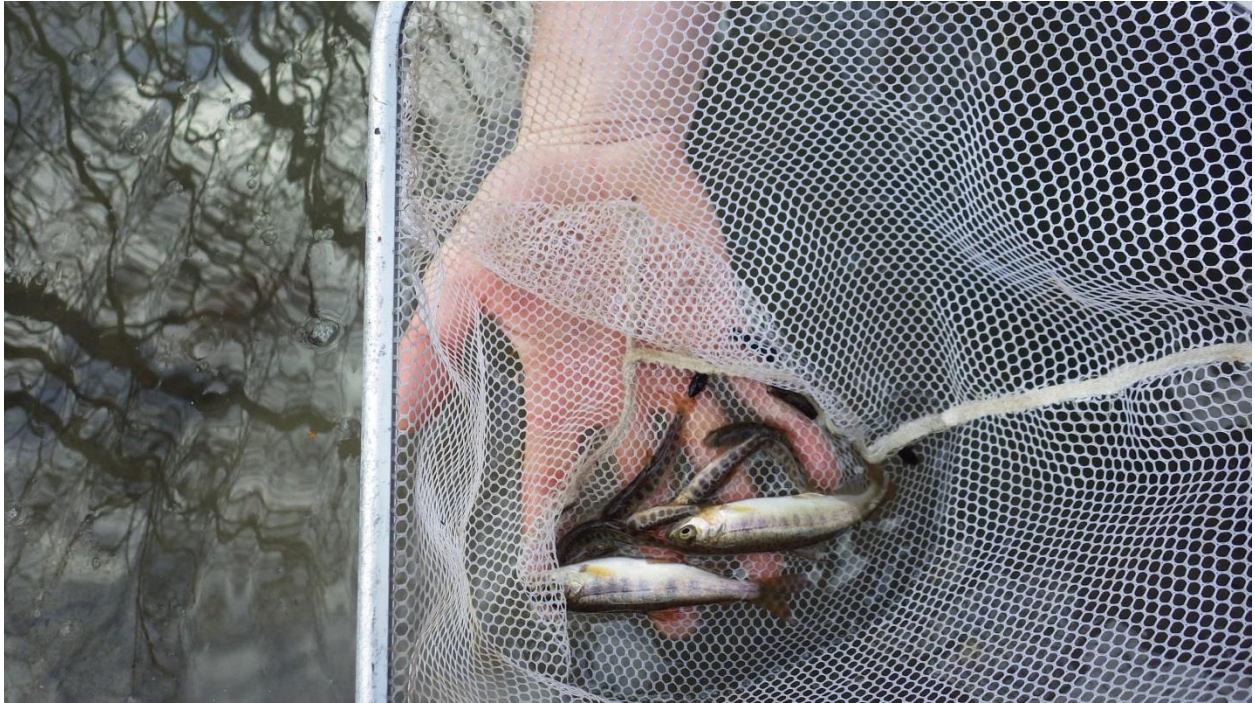
Figure 1.–2 coho salmon and 5 Dolly Varden char, waypoint 171.

115-34-10300**CORRECTION****Water body name:** Skagway River**Survey date:** 4/13/2017**Watershed:** Skagway River**Species & Lifestage:** CHp, COp, Kp, DVp, OUp**MTR:** C028S059 **Quad:** Skagway B-1**Findings:** We surveyed this stream using minnow traps and captured rearing coho salmon and Dolly Varden char (Table 1; Figures 1, 2).**Recommendations:** The original Skagway River nomination contains no fish capture data. Correct the upper extent of anadromy to reflect the documented capture of anadromous fish at waypoint 171 (Figure 2) and return for future investigations.**Nomination:** Pending

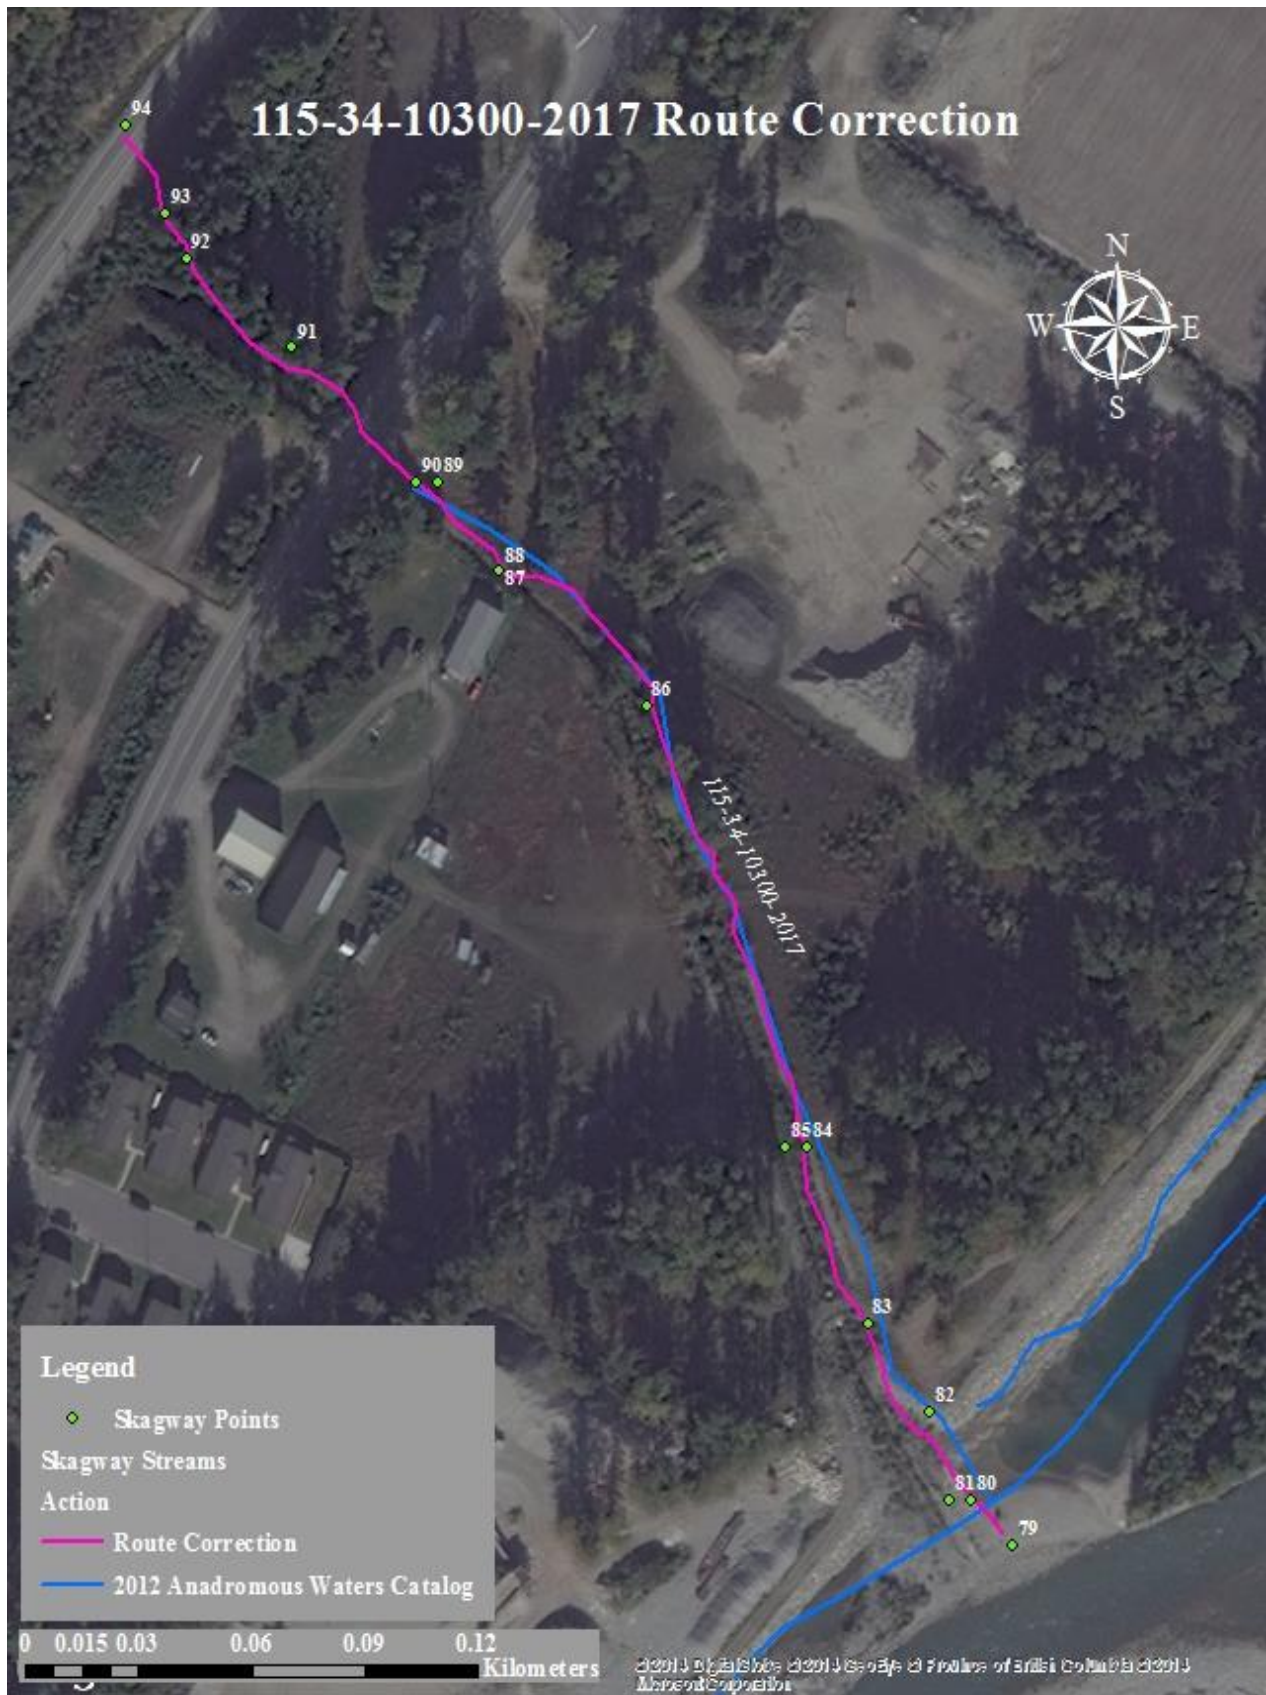
Figure 1.—115-34-10300-2017 route correction map.

Findings: We surveyed and tracked this stream and found juvenile coho salmon present past the current AWC upper extent (Table1). There is a barrier cascade just upstream of the culvert that passes under the Klondike Highway. Several juvenile coho salmon were in the pool under the cascade.

Recommendations: Extend coho salmon rearing for this stream in the AWC (Figure 1).

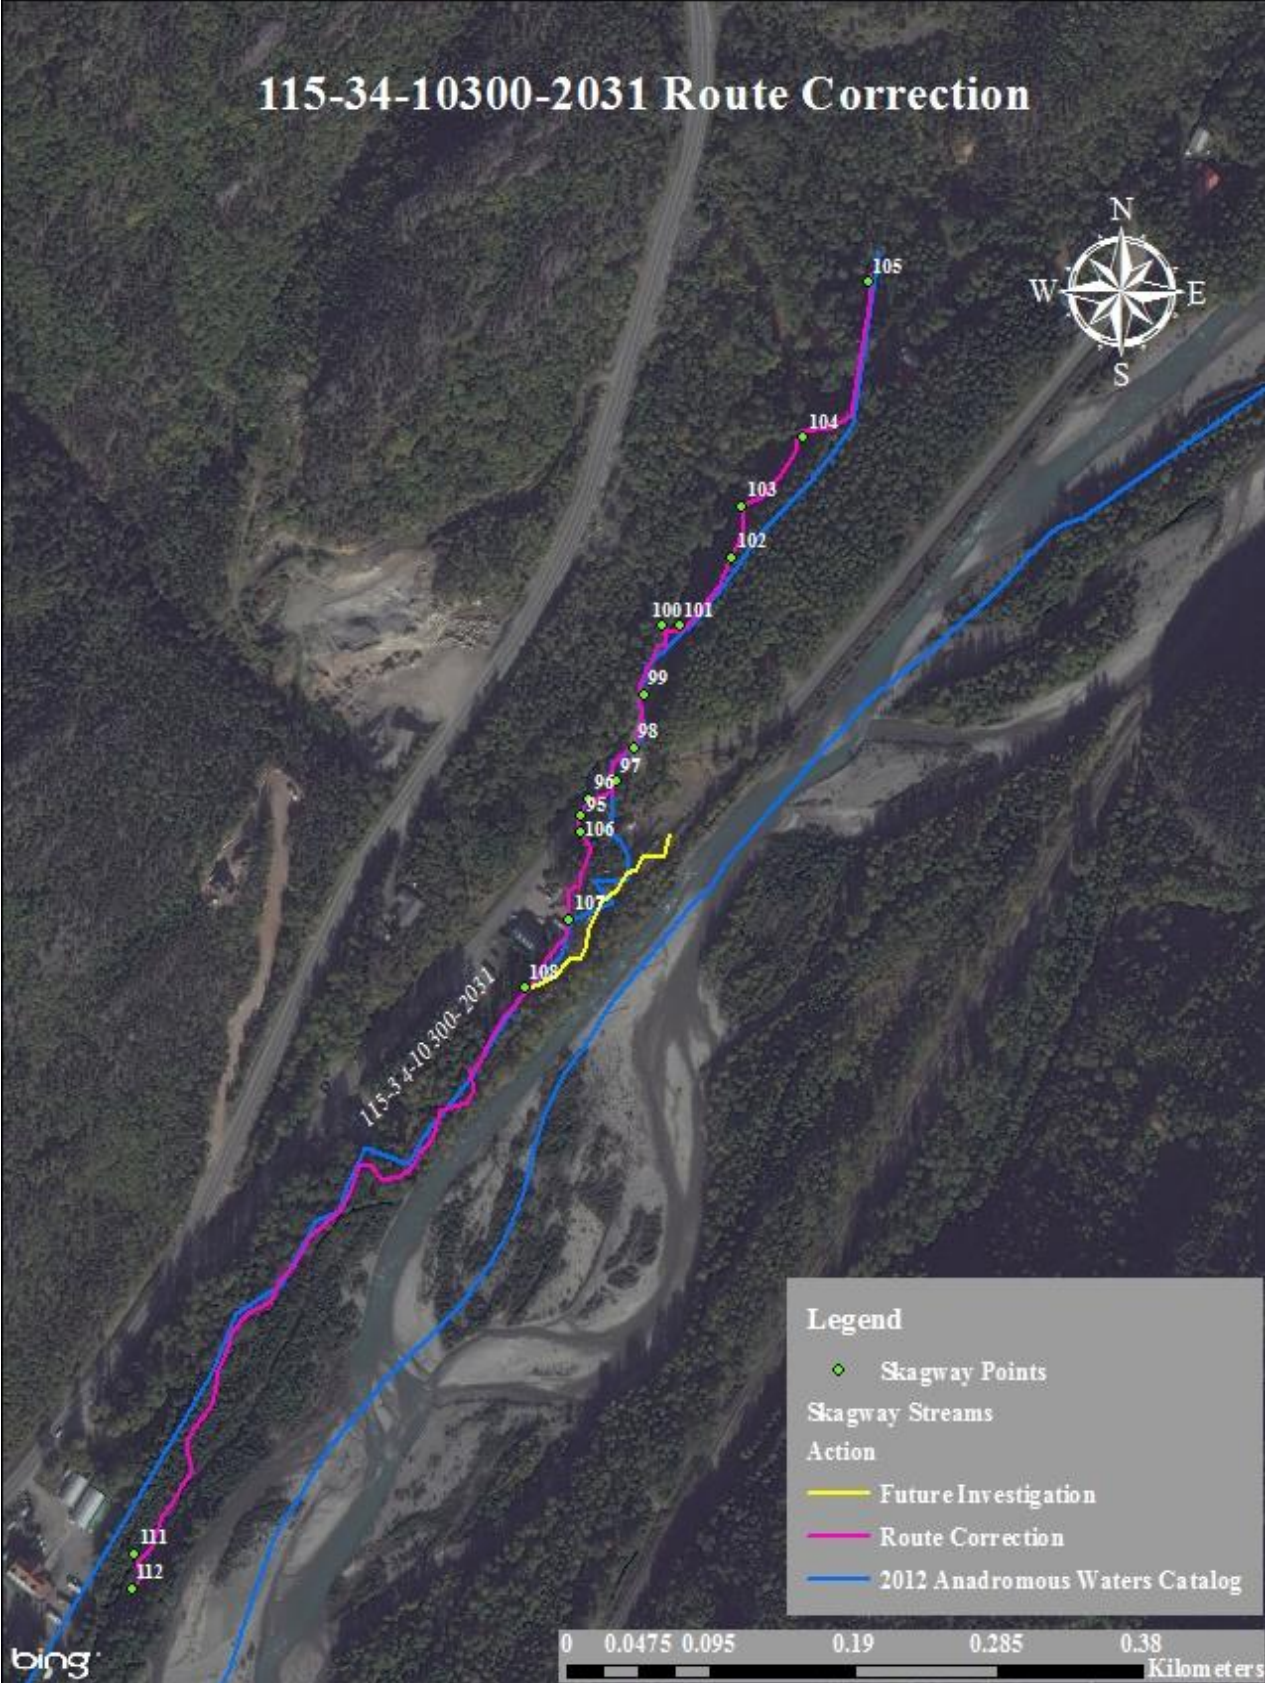
Figure 1.-115-34-10300-2031 route correction map.

115-34-10300-2031**CORRECTION****Water body name:****Survey date:** 8/29/2012**Water body number:** 115-34-10300-2031**Species & Lifestage:** CO, DVr**Watershed:** Skagway River**MTR:** C027S060E **Quad:** Skagway B-1**Findings:** We tracked and surveyed this stream and found its route differs from the catalog (Table 1). We followed stream to its confluence with Skagway River.**Recommendations:** Update stream route in AWC (Figure 1).**Nomination:** 12-615
