Alaska Department of Fish and Game

Habitat Section
Southeast Region

114-31-10130-2009

ADDITION

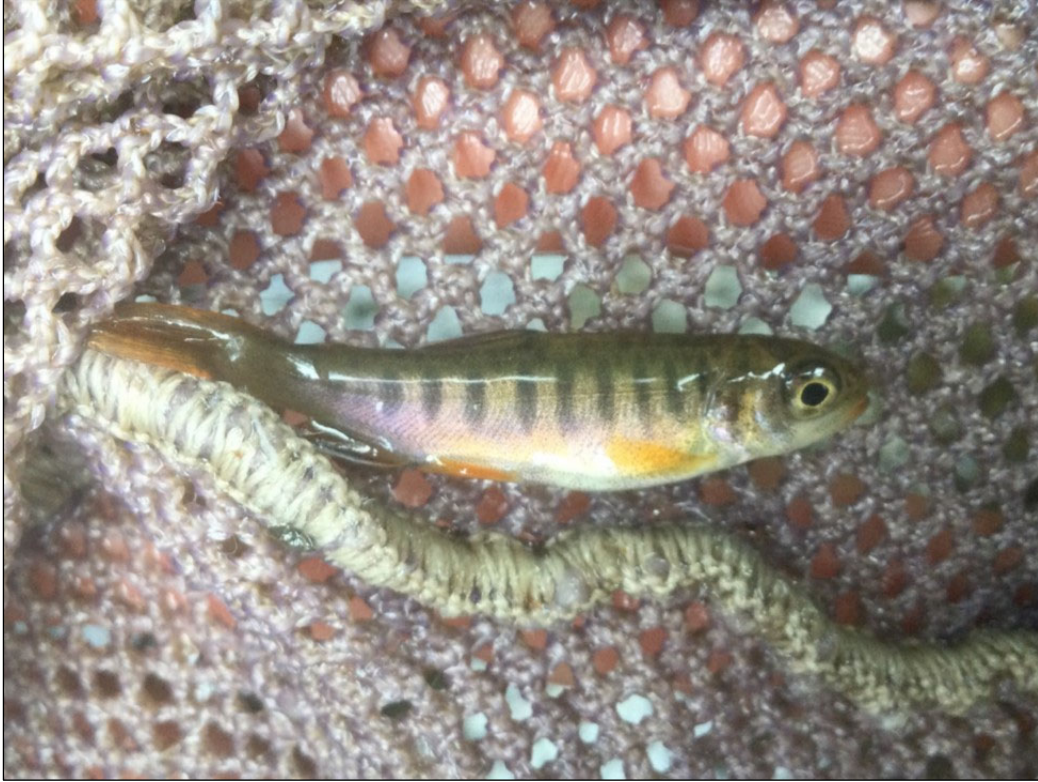
Figure 1.—Juvenile coho salmon captured at waypoint 2286.

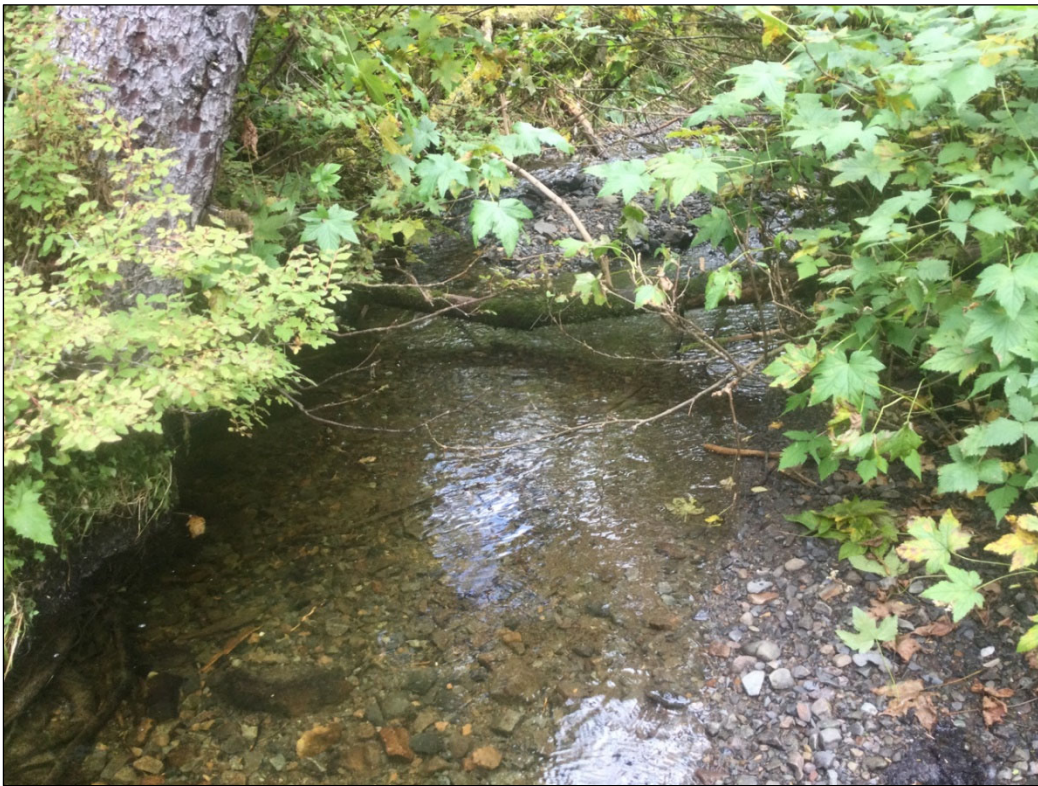
Findings: We surveyed this cataloged stream using a backpack electrofisher and GPS. We captured juvenile coho salmon and cutthroat trout. We also observed spawning pink salmon. The stream flows through a clear cut, where large woody debris is common in and around the channel, and continues downstream where it passes under a bridge (Table 1; Figures 1, 2).

Figure 2.—Channel at waypoint 2286.

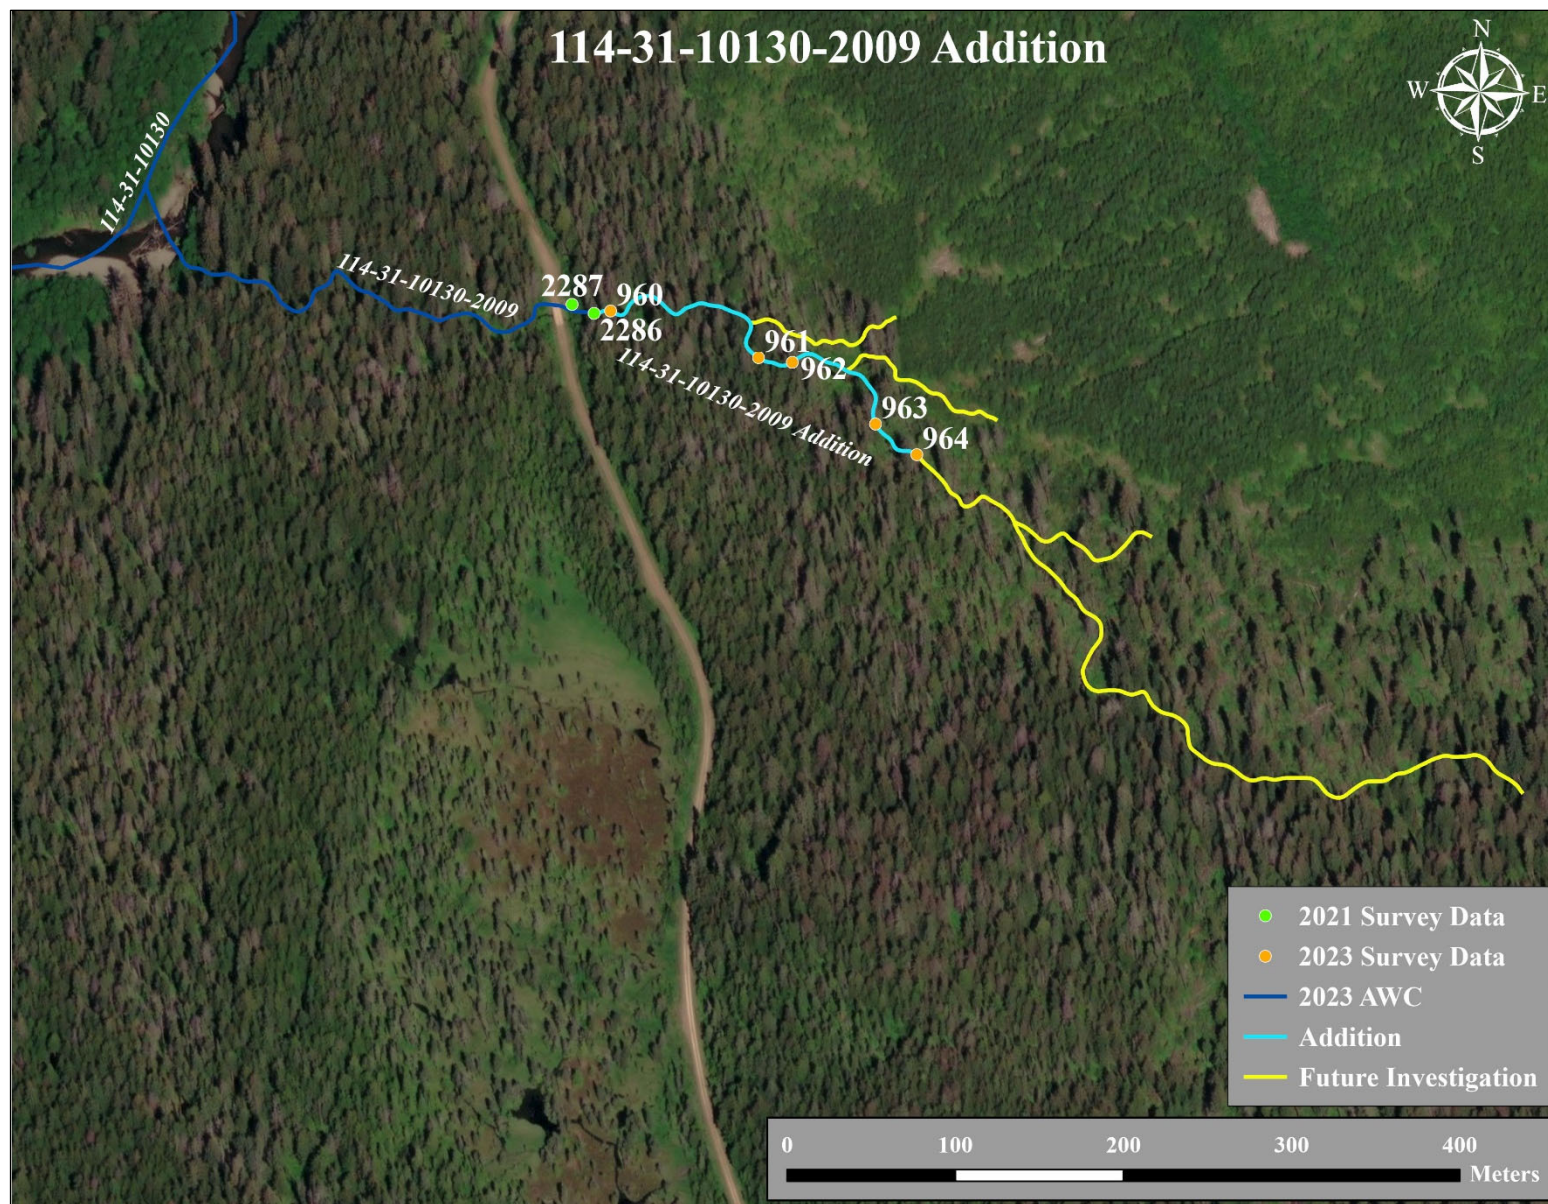
Figure 3.–Stream No. 114-31-10130-2009 addition map.

Recommendations: Extend upper extent of Stream No. 114-31-10130-2009 in the anadromous waters catalog (Figure 3).
