# Alaska Department of Fish and Game

Habitat Section  
Southeast Region

## 114-31-10130 Tributary 8

## ADDITION

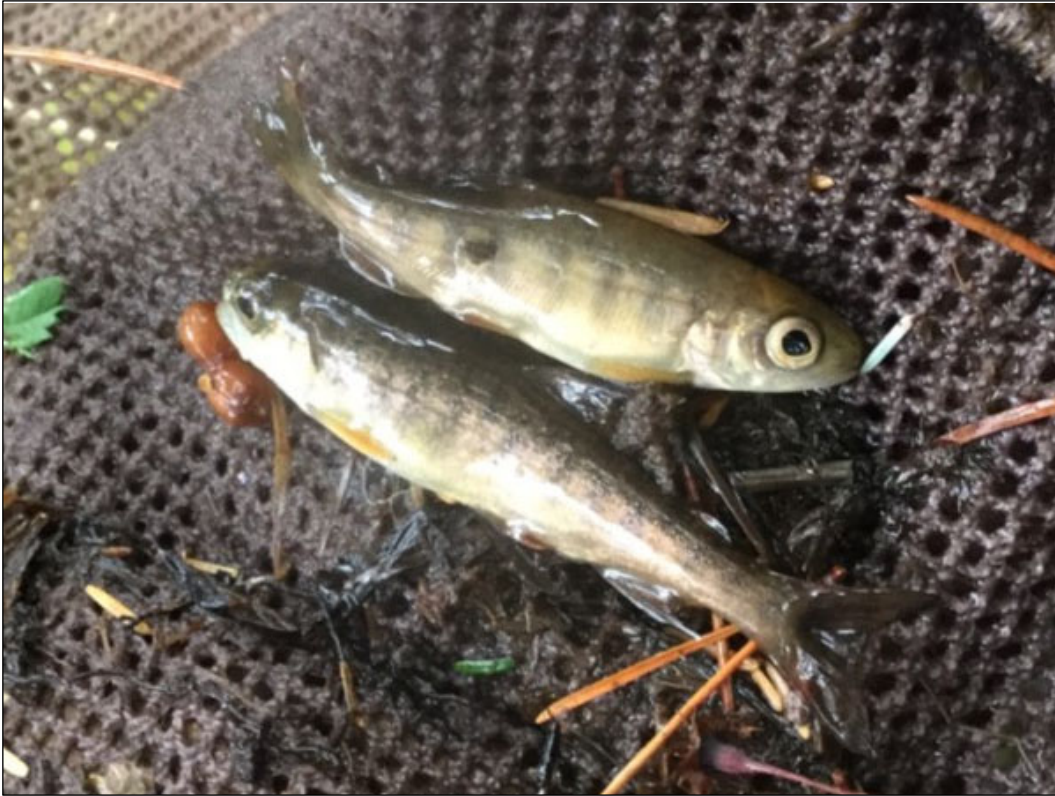
Figure 1.—Juvenile coho salmon captured at waypoint 1034.

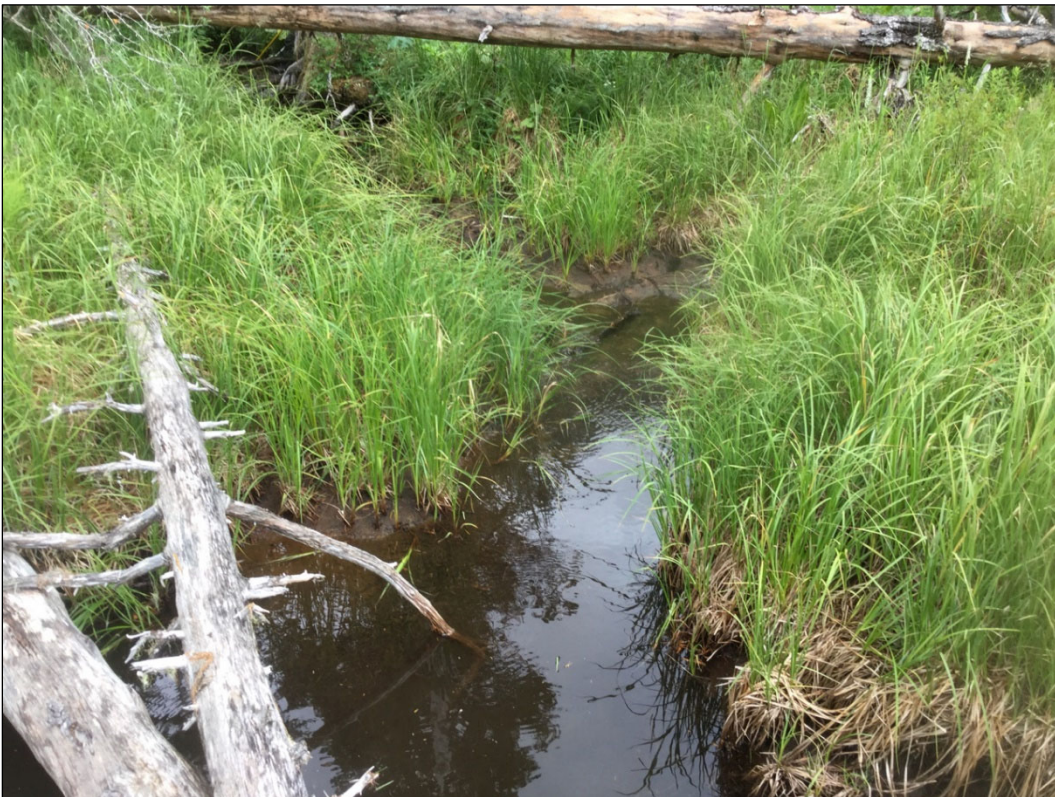
**Findings:** We surveyed this uncataloged stream using a backpack electrofisher and GPS. We captured juvenile coho salmon and Dolly Varden. The tributary stream descends a slight hillside and has a channel of fine organic sediment with cut banks (Table 1; Figures 1, 2).

Figure 2.—Channel at waypoint 1031.

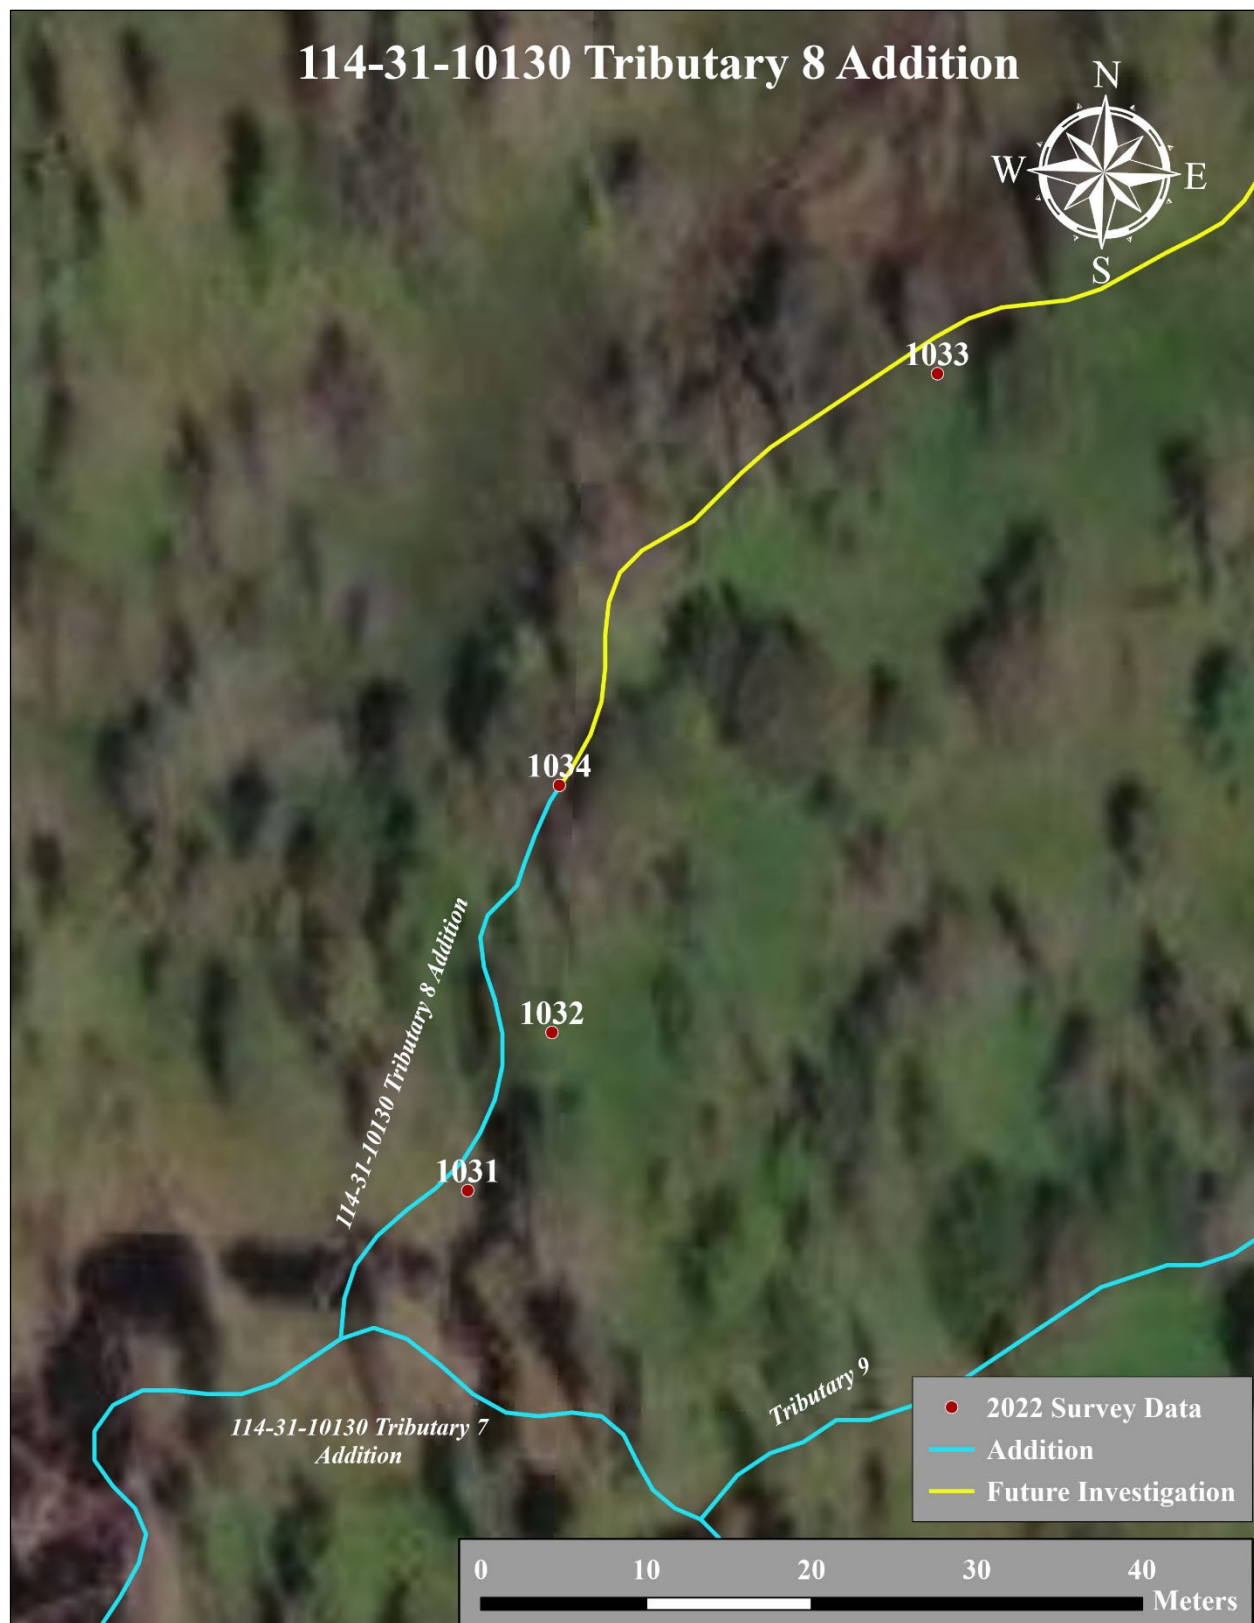
Figure 3.—114-31-10130 tributary 8 addition map.

**Recommendations:** Add this uncataloged stream to the anadromous waters catalog for rearing coho salmon (Figure 3).
