# Appendix D: Gull Cove

## Guide to direct fieldwork for cataloging anadromous water bodies in Southeast Alaska

# GULL COVE SURVEYS

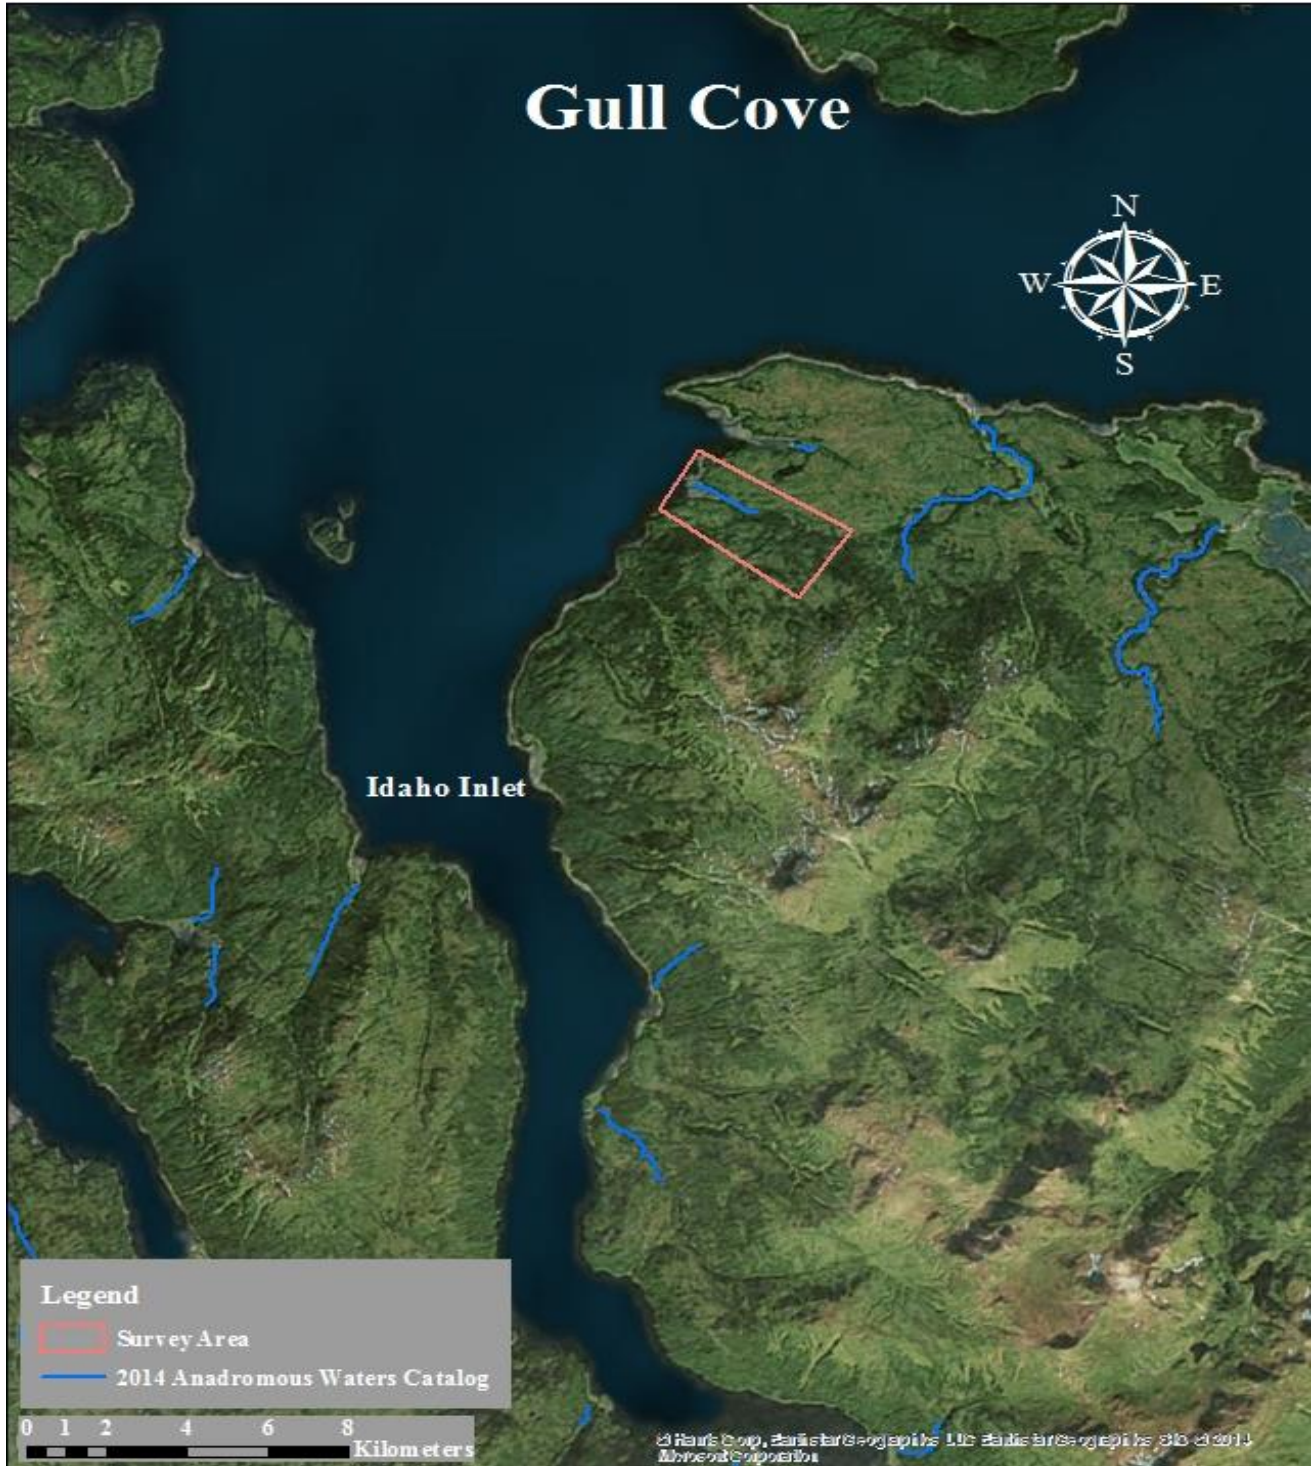
Figure 1.-Gull Cove survey map.

Gull Cove, located at the head of Idaho Inlet on the north side of Chichagof Island, provides a refuge for mariners during Icy Strait storms (Figure 1).

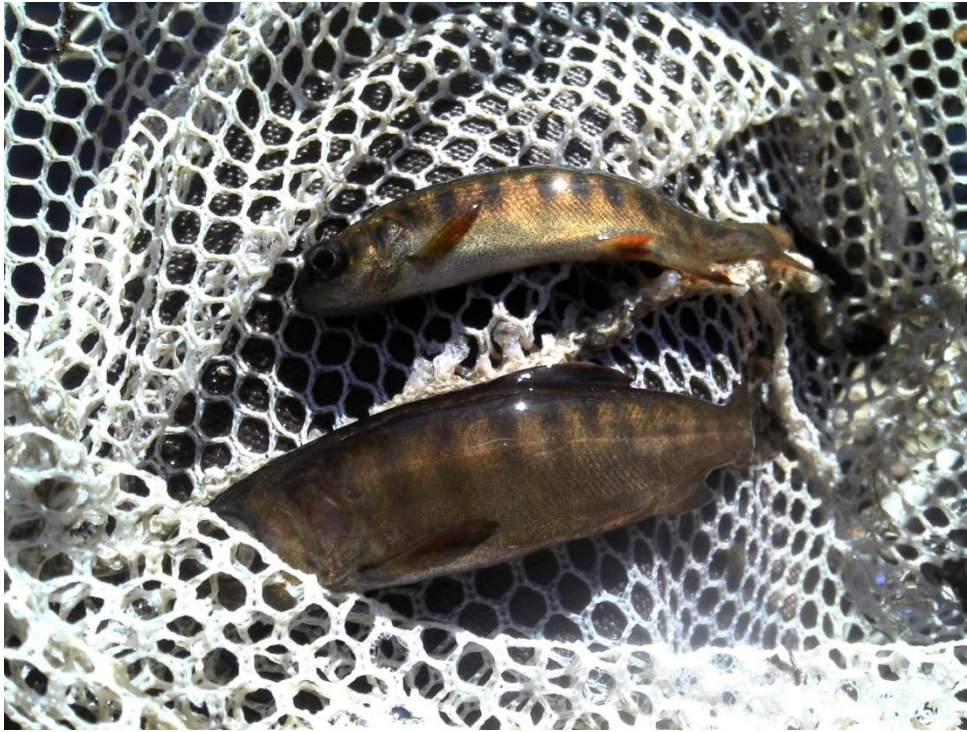
**Findings:** We surveyed this stream for fish using a GPS and a backpack electrofisher. The route for this stream differs from the current AWC. We captured rearing coho salmon throughout the stream, including above the current anadromous section (Table 1, Figure 1). Due to time constraints we had to stop the survey early, there was no change in the habitat so there is a possibility there are salmon above where we ended survey.

Figure 1.–Coho salmon caught in stream number 114-40-10280.

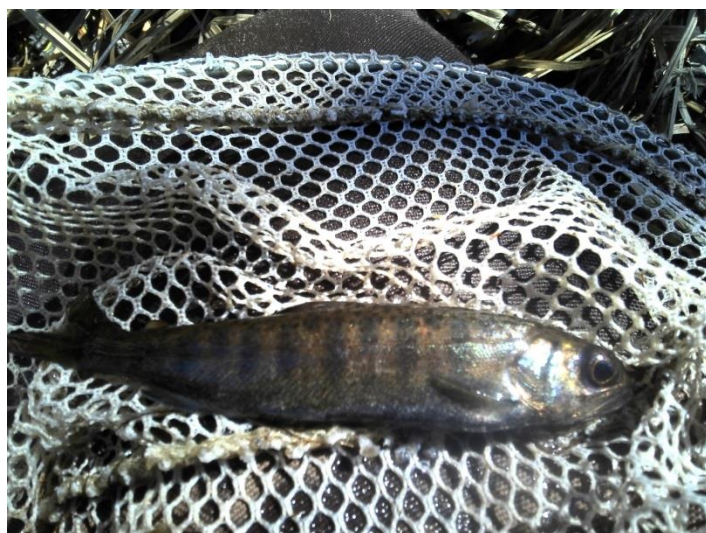
**Findings:** We tracked and fish sampled in stream number 114-40-10280-2007 using a GPS and a backpack electrofisher (Table 1). We caught juvenile coho salmon, Dolly Varden char, and cutthroat trout (Figure 1). We encountered a 4' drop in the stream into a small pool that could be a potential fish barrier (Figure 2). We electrofished and minnow trapped above the drop and caught no fish. The stream meanders through a forested area and transitions into meadows.

Figure 1.–Coho salmon caught in 114-40-10280-2007.

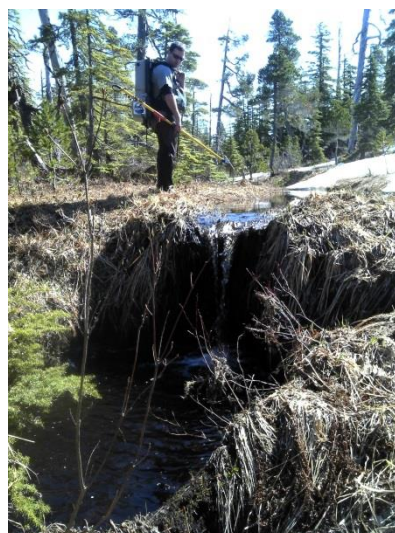
Figure 2.–Rick Hoffman standing above 4' drop in 114-40-10280-2007.

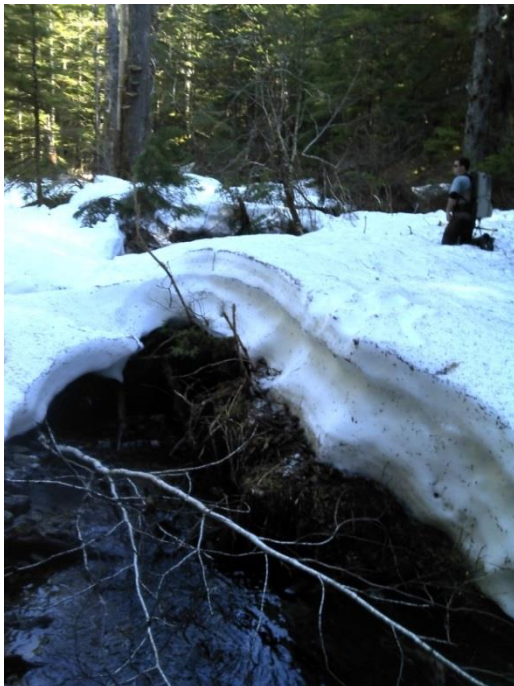
Figure 1.—114-40-10280-2022.

**Findings:** We tracked and fish sampled stream number 114-40-10280-2022 using a GPS and backpack electrofisher (Table 1). We caught juvenile coho salmon, Dolly Varden char, and cutthroat trout. We stopped the survey when the creek became much steeper and there was too much snow to continue (Figure 1).
